TEST REPORT

Report No. : HL10012A/2007

Product Description: Chair Base
Style/Item No.: A300
Manufacturer/Vendor: FUH SHYANG CO., LTD.
Country of Origin: Taiwan

Test Required: Sect. 7 Base Test - Static of ANSI/BIFMA X5.1-2002

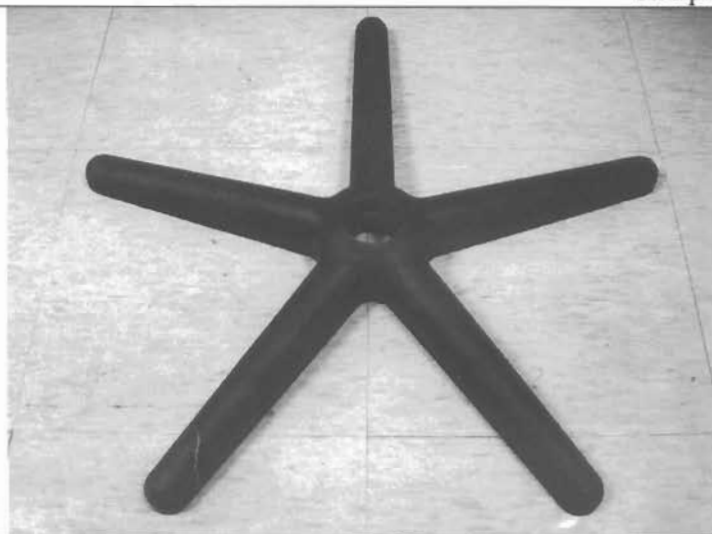
"Photo A" - Appearance of sample - Face

Sample	Broken load	Result	Remark
A300	5591.30 lbf	Pass	Maximum broken load.

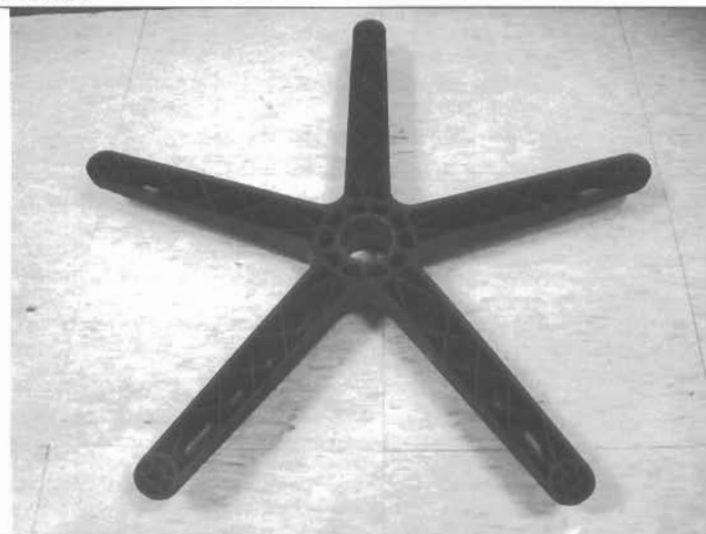
"Photo B" - Appearance of sample - Back
