TEST REPORT

Report No. : HL20099A/2007

Product Description: Chair Base
Style/Item No.: H325
Manufacturer/Vendor: FUH SHYAN CO., LTD.
Country of Origin: Taiwan

Test Required: Sect. 7 Base Test - Static of ANSI/BIFMA X5.1-2002

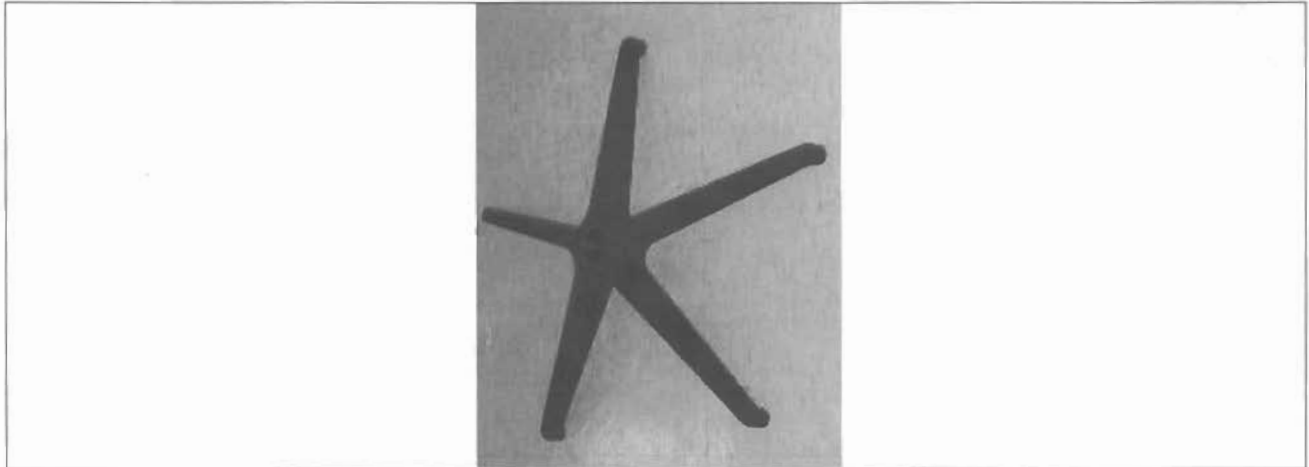
“Photo A”- Sample Picture

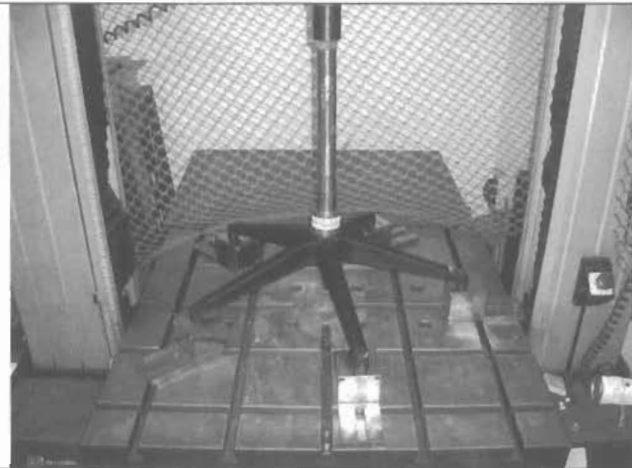
“Photo B”- Test Method

- 1) Place the base on a test platform with blocks under base arms.
- 2) A force of 11,120N (2,500 lbf) shall be applied for 1 minute.
- 3) Remove the force.
- 4) Apply a second force of 11,120N (2,500 lbf) for 1 minute.
- 5) Remove the load and evaluate the product in accordance with the acceptance level Section 7.5.
- 6) Increase the load until the chair base is broken. (Requested by the client).

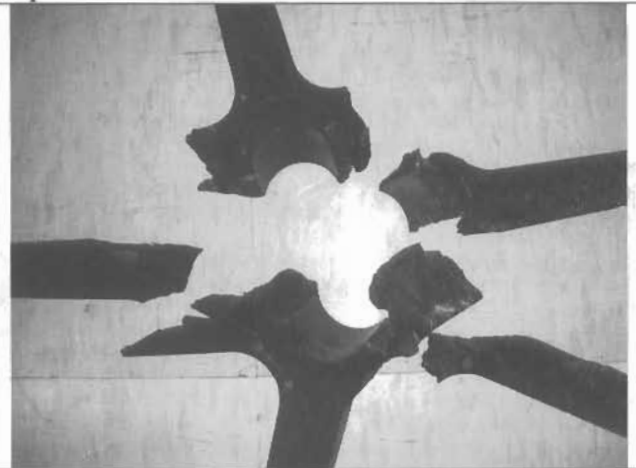
“Photo C”- After Test

Sample	Broken load	Result	Remark
H325	3125.6 lbf	Pass	Maximum broken load.
