## TEST REPORT

Report No. : HL20172/2007  
 Page : 1 of 2  
 Date : FEB. 15, 2007

Product Description: Chair Base  
Style/Item No.: C300  
Manufacturer/Vendor: FUH SHYANG CO., LTD.  
Country of Origin: Taiwan

Test Required: Sect. 7 Base Test - Static of ANSI/BIFMA X5.1-2002

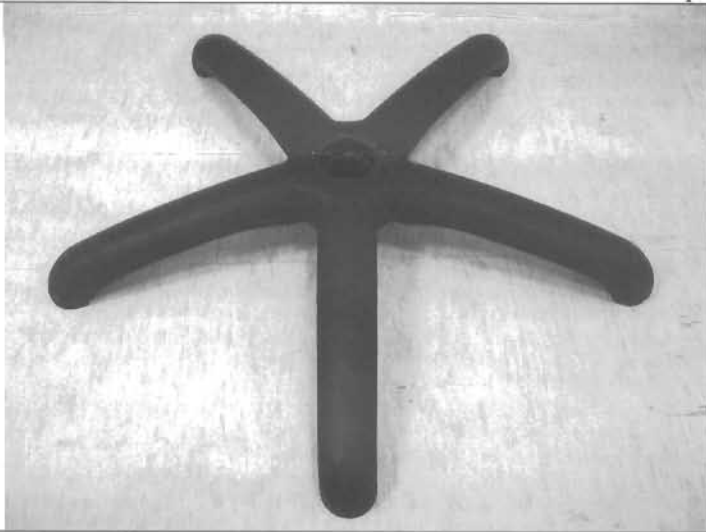
"Photo A" - Appearance of sample - Face

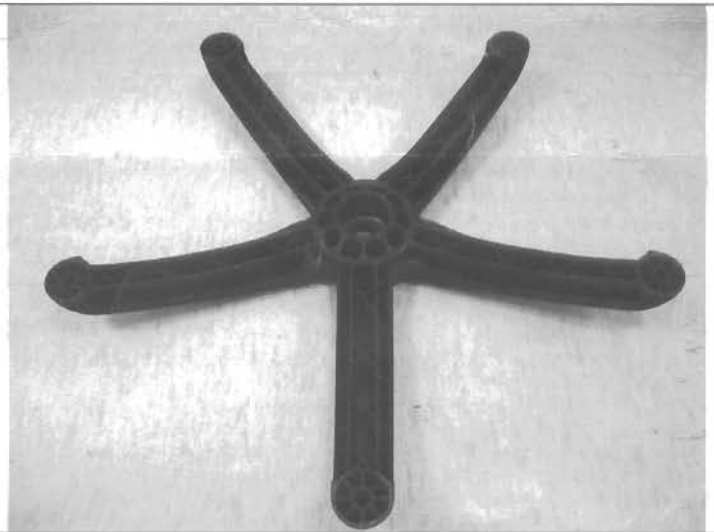
"Photo B" - Appearance of sample - Back

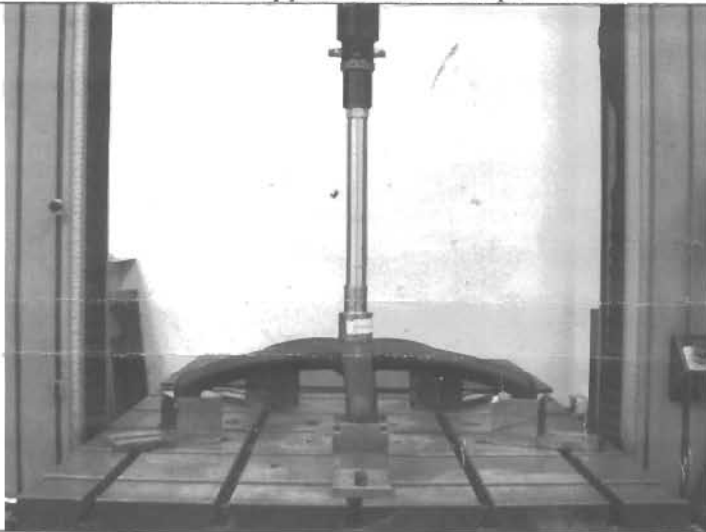
"Photo C" - Test Setup

- 1) Place the base on a test platform with blocks under base arms.
- 2) A force of 11,120N (2,500 lbf) shall be applied for 1 minute.
- 3) Remove the force.
- 4) Apply a second force of 11,120N (2,500 lbf) for 1 minute.
- 5) Remove the load and evaluate the product in accordance with the acceptance level Section 7.5.
- 6) Increase the load until the chair base is broken. (Requested by the client).

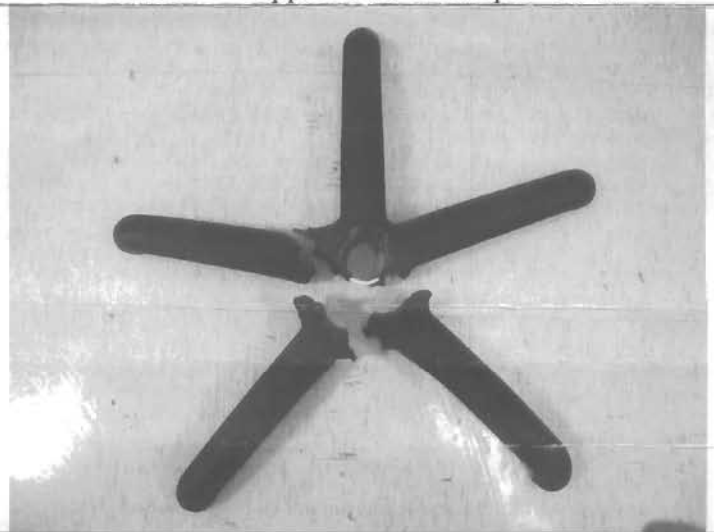
"Photo D" - After Test

Sample	Broken load	Result	Remark
C300	3239.7 lbf	<b>Pass</b>	Maximum broken load.
