## TEST REPORT

Report No. : HL10012/2007  
 Page : 1 of 2  
 Date : JAN. 10, 2007

Product Description: Chair Base  
Style/Item No.: A270  
Manufacturer/Vendor: FUH SHYANG CO., LTD.  
Country of Origin: Taiwan

Test Required: Sect. 7 Base Test - Static of ANSI/BIFMA X5.1-2002

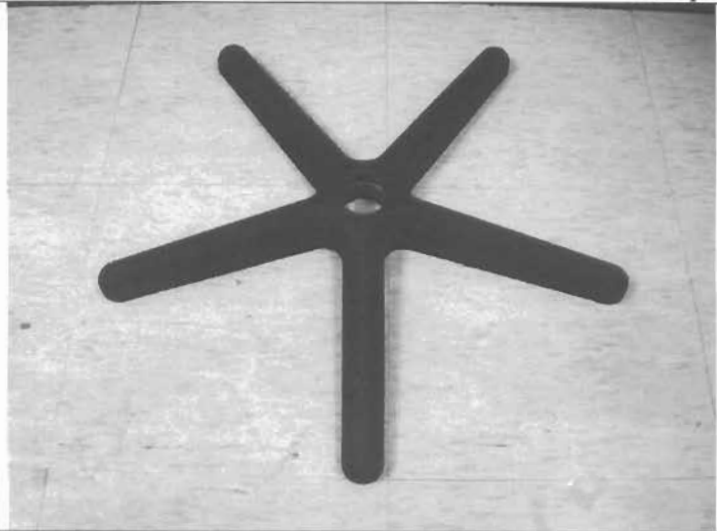
"Photo A" - Appearance of sample - Face

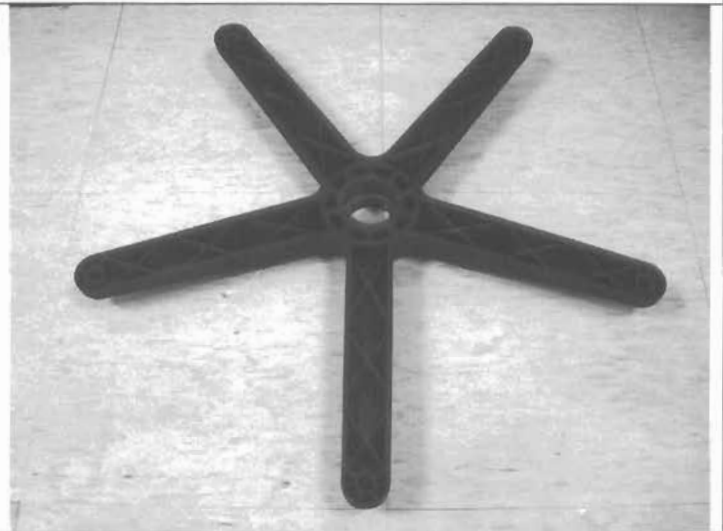
"Photo B" - Appearance of sample - Back
