TEST REPORT

Report No. : HL20099/2007
Page : 1 of 2
Date : FEB. 13, 2007

Product Description: Chair Base
Style/Item No.: H300
Manufacturer/Vendor: FUH SHYAN CO., LTD.
Country of Origin: Taiwan

Test Required: Sect. 7 Base Test - Static of ANSI/BIFMA X5.1-2002

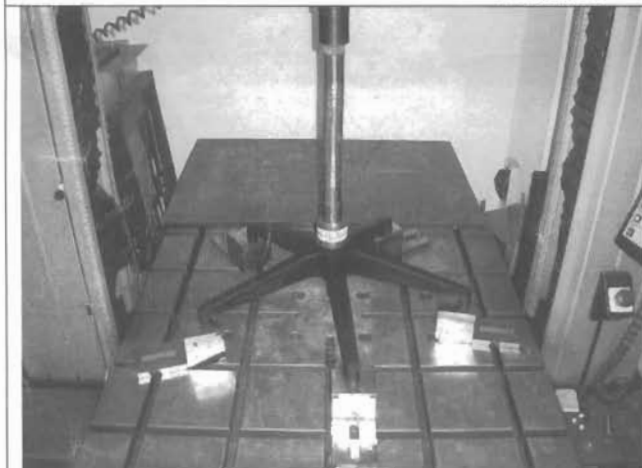
“Photo B”- Test Method

- 1) Place the base on a test platform with blocks under base arms.
- 2) A force of 11,120N (2,500 lbf) shall be applied for 1 minute.
- 3) Remove the force.
- 4) Apply a second force of 11,120N (2,500 lbf) for 1 minute.
- 5) Remove the load and evaluate the product in accordance with the acceptance level Section 7.5.
- 6) Increase the load until the chair base is broken. (Requested by the client).

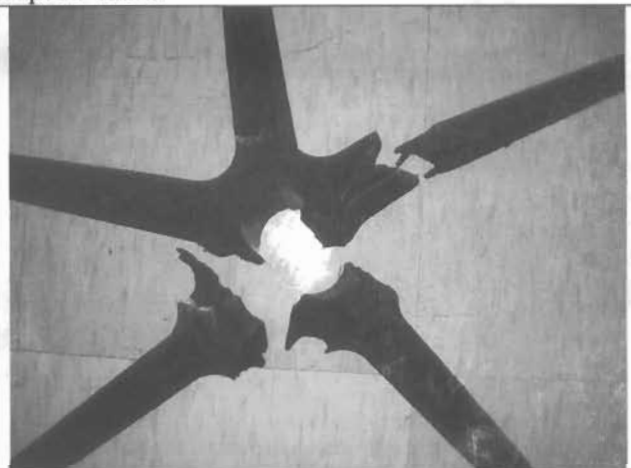
“Photo C”- After Test

Sample	Broken load	Result	Remark
H300	3690.6 lbf	Pass	Maximum broken load.
