## TEST REPORT

Report No. : HL20173/2007

Product Description: Chair Base  
Style/Item No.: C320  
Manufacturer/Vendor: FUH SHYANG CO., LTD.  
Country of Origin: Taiwan

Test Required: Sect. 7 Base Test - Static of ANSI/BIFMA X5.1-2002

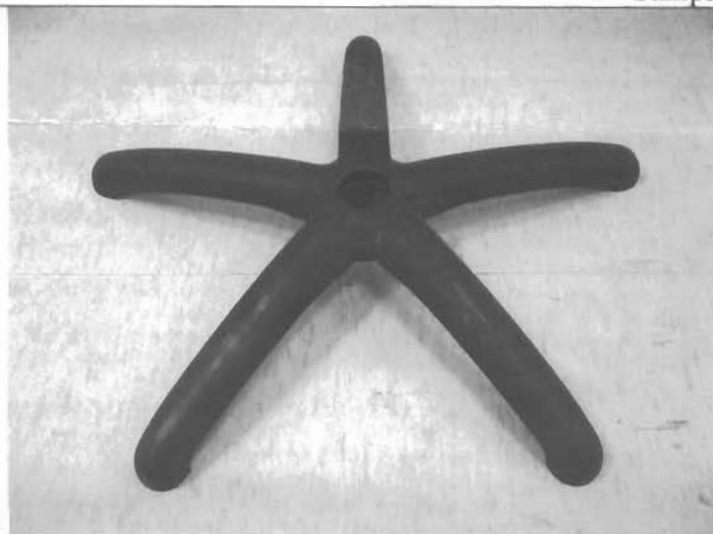
"Photo A" - Appearance of sample - Face

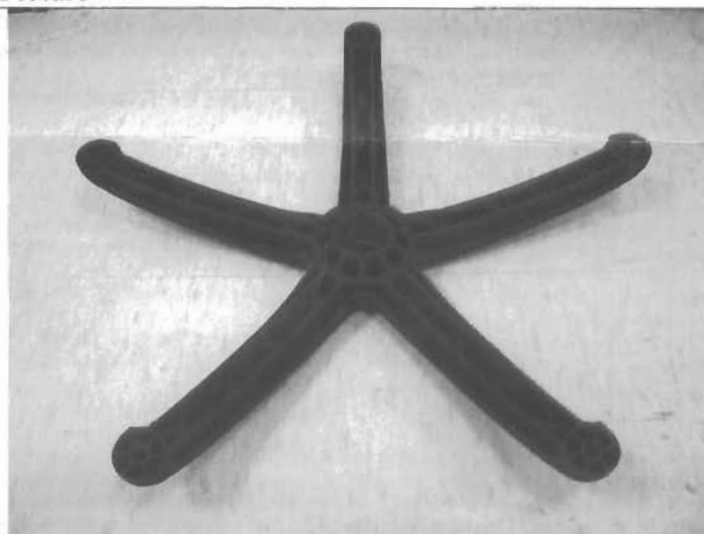
"Photo B" - Appearance of sample - Back

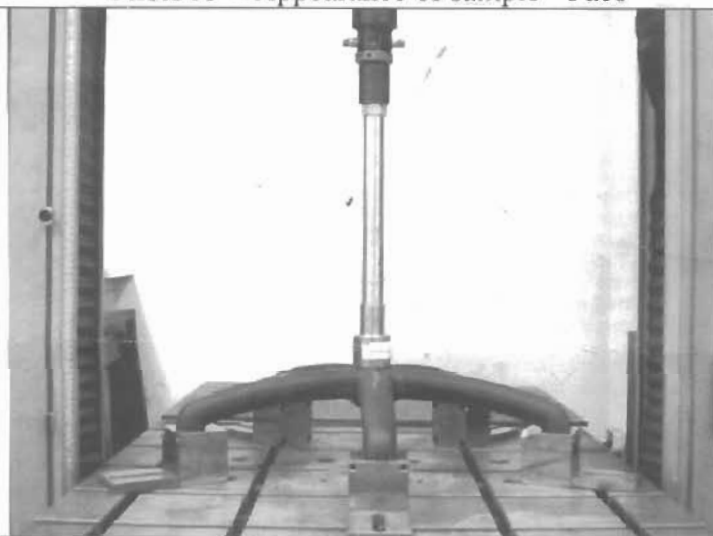
"Photo C" - Test Setup

- 1) Place the base on a test platform with blocks under base arms.
- 2) A force of 11,120N (2,500 lbf) shall be applied for 1 minute.
- 3) Remove the force.
- 4) Apply a second force of 11,120N (2,500 lbf) for 1 minute.
- 5) Remove the load and evaluate the product in accordance with the acceptance level Section 7.5.
- 6) Increase the load until the chair base is broken. (Requested by the client).

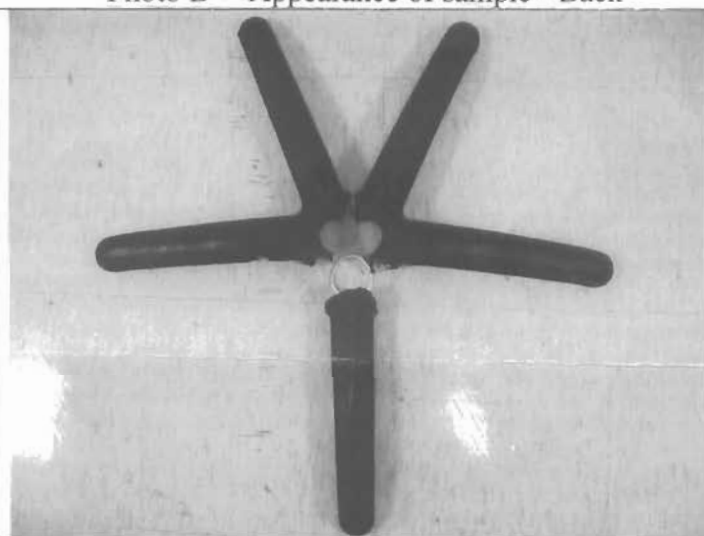
"Photo D" - After Test

Sample	Broken load	Result	Remark
C320	4115.5 lbf	<b>Pass</b>	Maximum broken load.
